Project No: **BDHRN002**Job Card No **0026**

Job Description: **GVI Engine 2 S-duct**

**>54-42-00-210-801- GENERAL VISUAL INSPECTION OF THE NO. 2 ENGINE S-DUCT
01**

TASK 54-42-00-210-801 GENERAL VISUAL INSPECTION OF THE ENGINE 2 S-DUCT

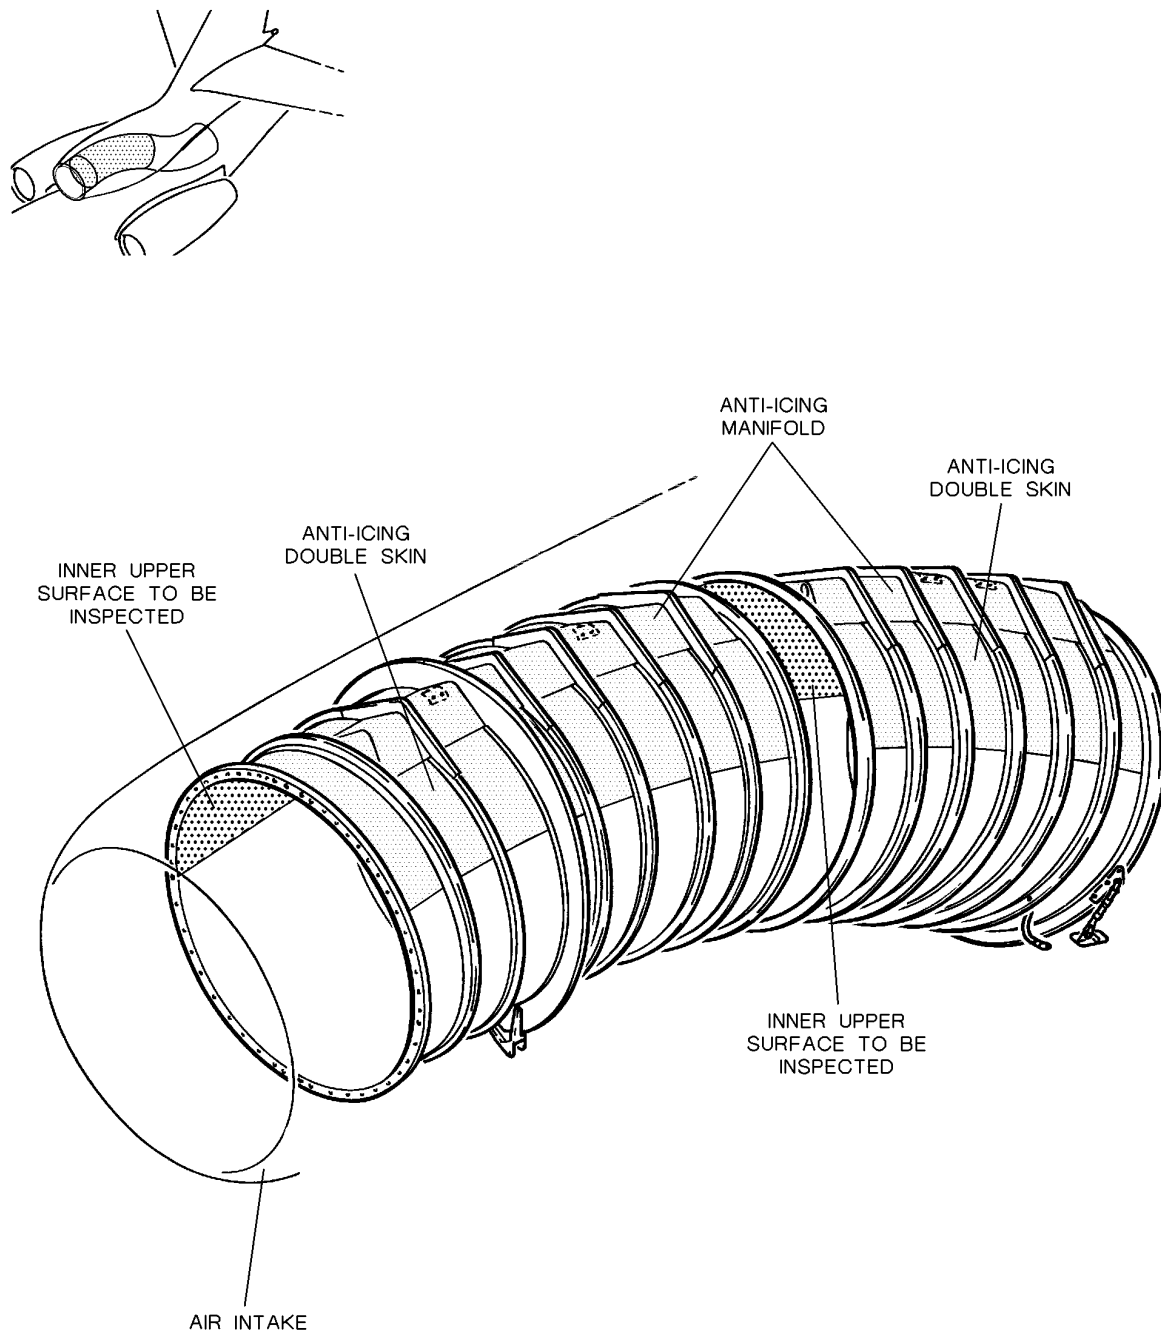
Figure 1: Visual Inspection of Engine No. 2 S-duct

- (1) Carefully inspect the inner upper section of the S-duct below the anti-icing manifolds and the anti-icing double skins ([fig. 1](#)).
 - (a) Check for cracks on the inner upper surface of the S-duct.
 - (b) Check for signs of overheating on the inner upper surface of the S-duct.

NOTE: If cracks or signs of overheating (brownish spots) are found, contact the manufacturer.
- (2) On the inner skin paint coat:
 - (a) If corrosion is found, refer to SRM (Refer to [SRM 51-10-02](#)).

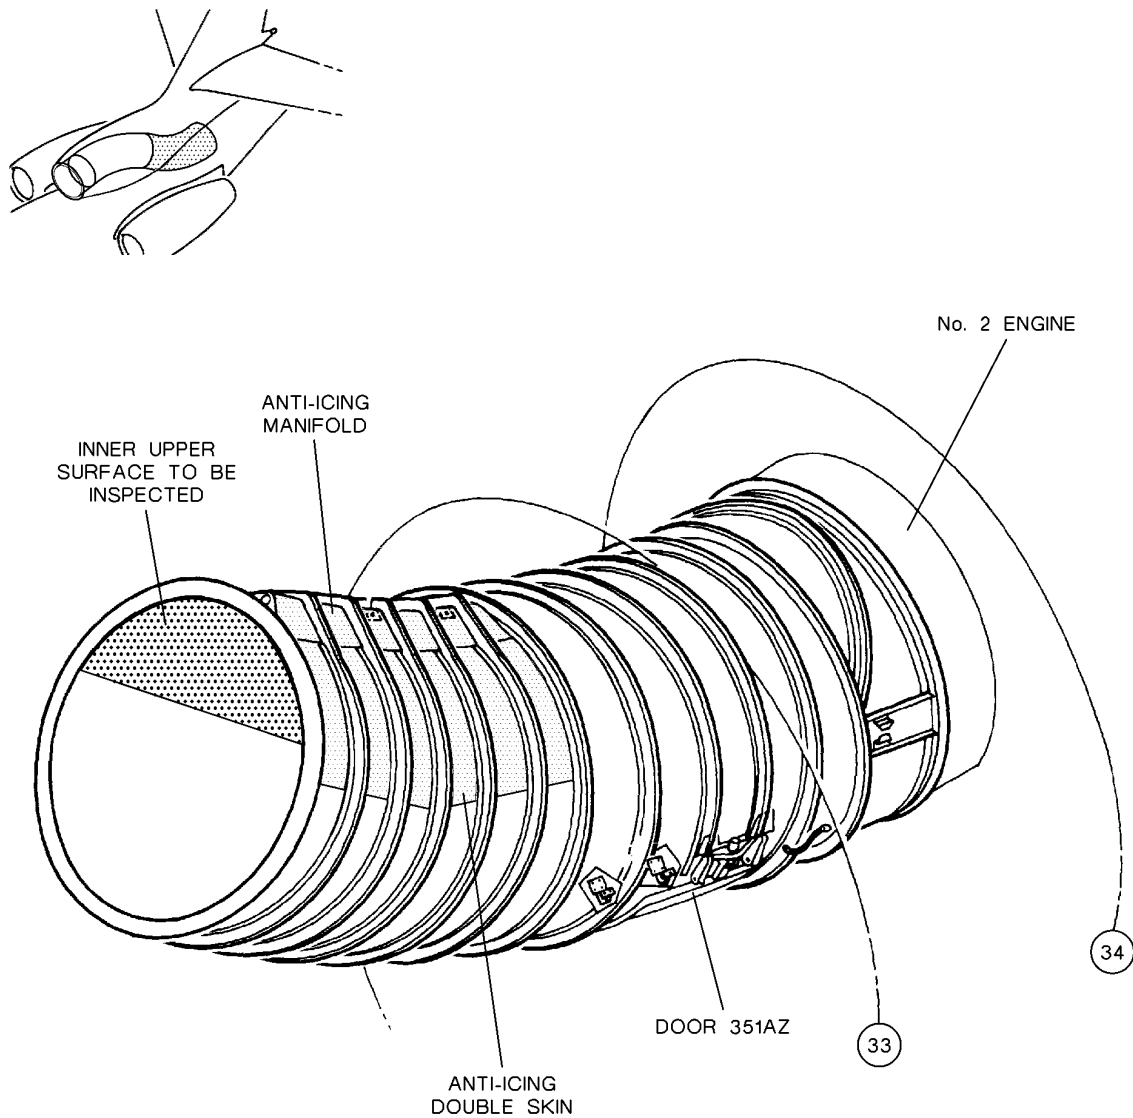
Figure 2: Visual Inspection of Engine No. 2 S-duct

- (b) If the protective paint is damaged or after corrosion treatment, renew the **top coat PU66** paint scheme (Refer to **TASK 20-60-00-370-803**).
- B. Visual inspection through door (**351AZ**) (**fig. 2**).
 - (1) Carefully inspect the inner upper section of the S-duct below the anti-icing manifolds and the anti-icing double skins, proceeding in the same way as for the inspection through engine 2 air intake.
 - (2) On the inner skin paint coat:
 - (a) If corrosion is found, refer to SRM (Refer to **SRM 51-10-02**).
 - (b) If the protective paint is damaged or after corrosion treatment, renew the **top coat PU66** paint scheme (Refer to **TASK 20-60-00-370-803**).
