Model.: F900EX

Job Description: **SERV Emergency Exit Door**

AIRWORTHINESS CODE RELATED TO CH5.40: 52-20-00-610-801

FALCON 900EX AIRCRAFT MAINTENANCE MANUAL

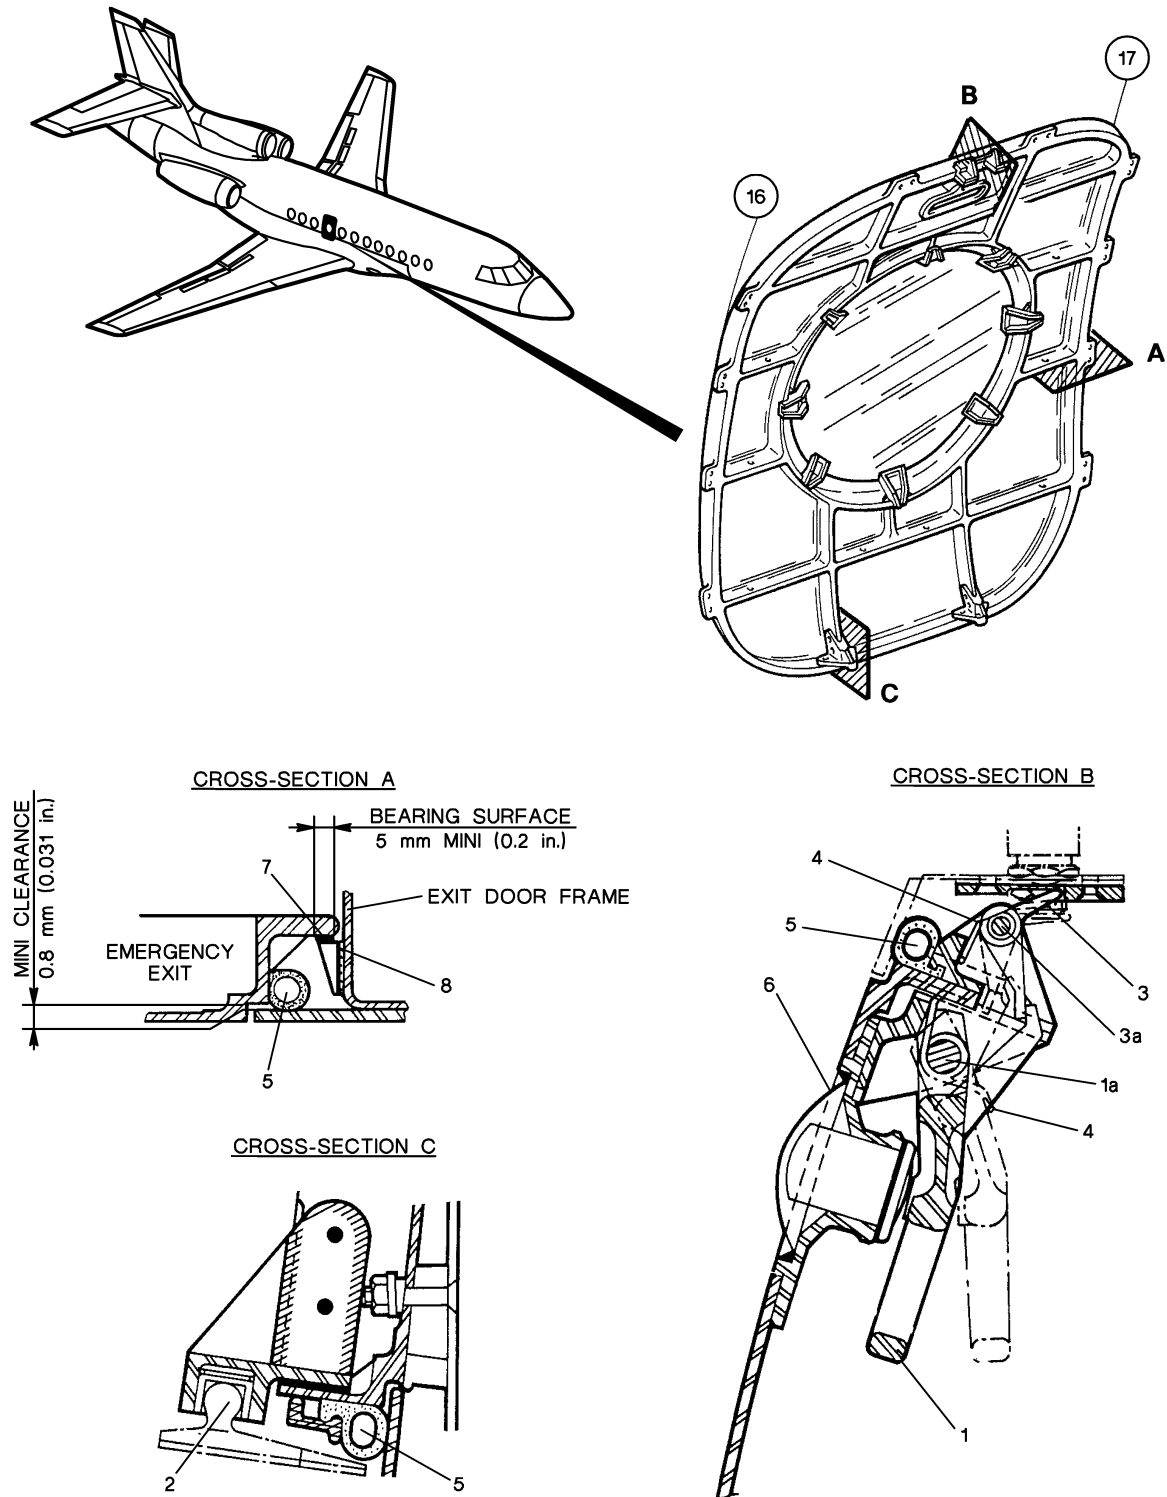
Figure 1: Emergency Exit - Structure and Locking Mechanism

(A/C without M3953)

Refer to **fig. 1** and **fig. 2**

- (2) On the frame
 - (a) Check the condition of the fuselage side of the frame (seal support), paying particular attention to the two lower ball-joints (2) (**fig. 1** or **fig. 2**: cross-section C).

- (c) Check of wear on the stops (8)
 - 1 Apply **prussian blue** or **developer** on each emergency exit door stops (**fig. 1** or **fig. 2** : cross-section A, item (7)).

- 3 In the area adjacent to each stops, check the clearance between the inner section of the frame and the emergency exit door. It must be greater than or equal to 0.8 mm (0.031 in) (**fig. 1** or **fig. 2** : cross-section A).

- 4 Remove the emergency exit door (**EMERG**).
 - 5 Check that the size of the bearing surface (surface without **prussian blue** or **developer**) is greater than or equal to 5 mm (0.2 in) (**fig. 1** or **fig. 2** : cross-section A).

- If necessary, clean with **water abrasive paper** (grade 1200).
- C. Lubrication (**fig. 1** or **fig. 2**)
- (1) Locking mechanism
 - (a) While slowly actuating the handle (1), lubricate the following parts with **lubricating oil**:

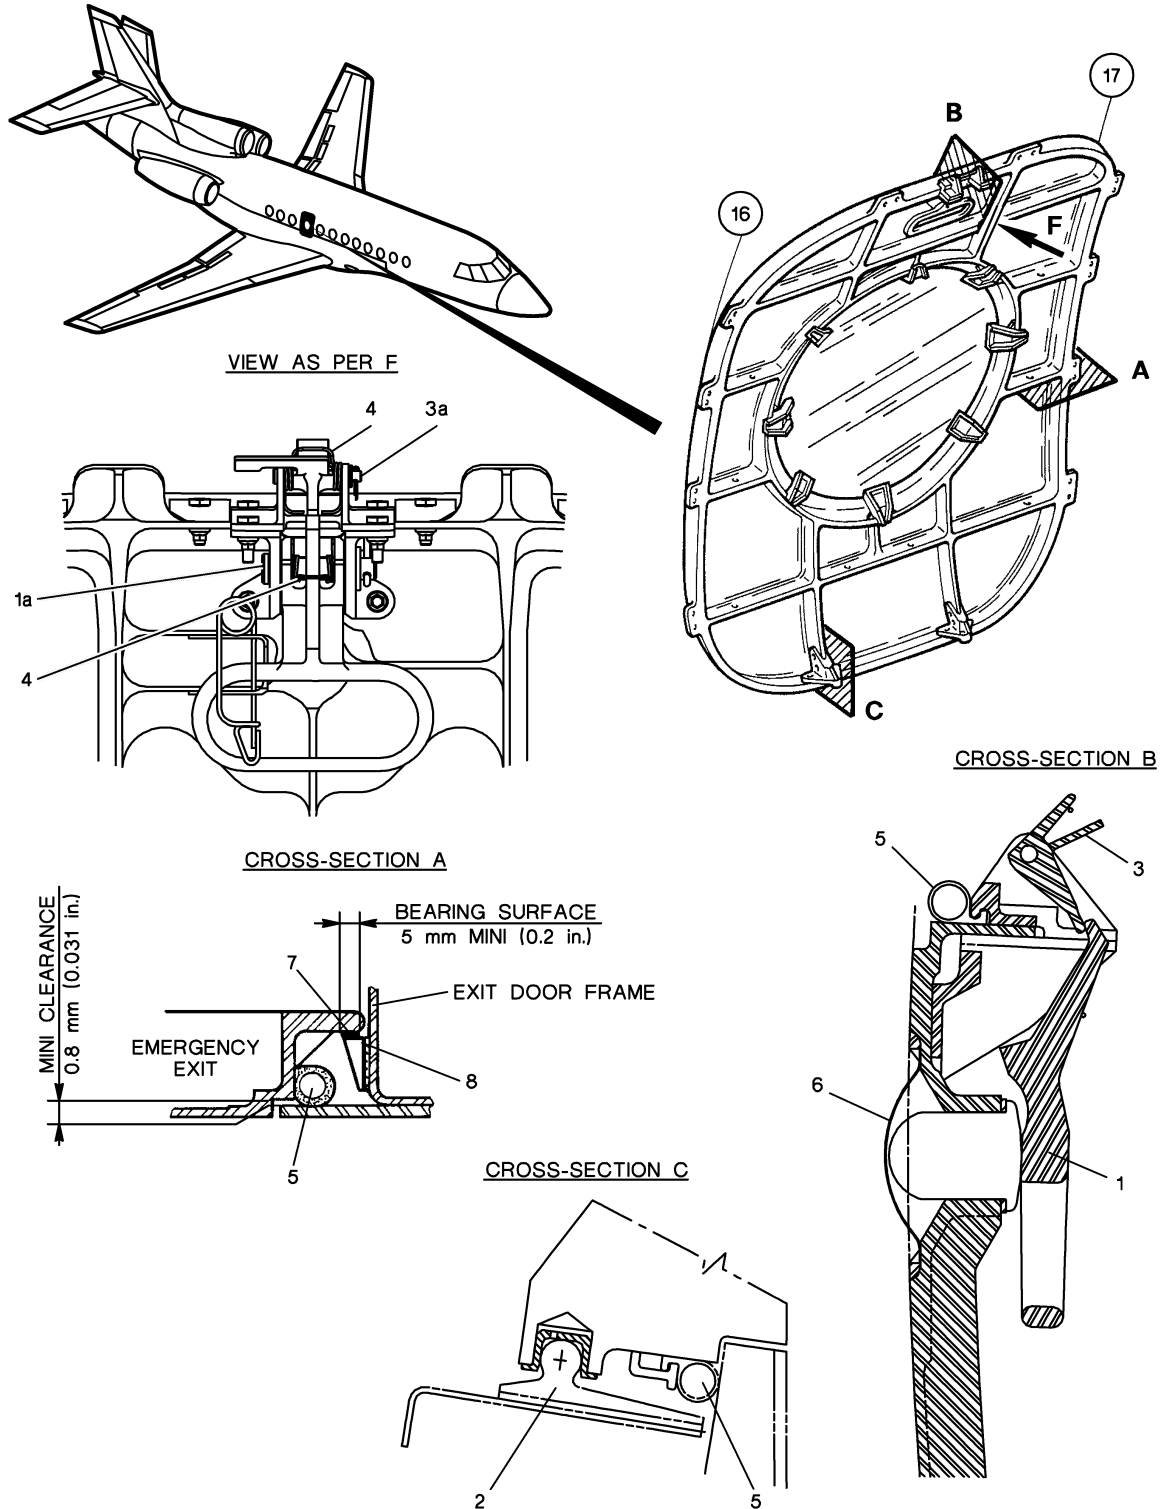
Figure 2: Emergency Exit - Structure and Locking Mechanism

(A/C with M3953)
