Project No: **BDHRN002**Job Card No **0114**

Job Description: **Calibrate RAD/ALT 1 RX/TX(2sa)**

## FALCON 900EX AIRCRAFT MAINTENANCE MANUAL

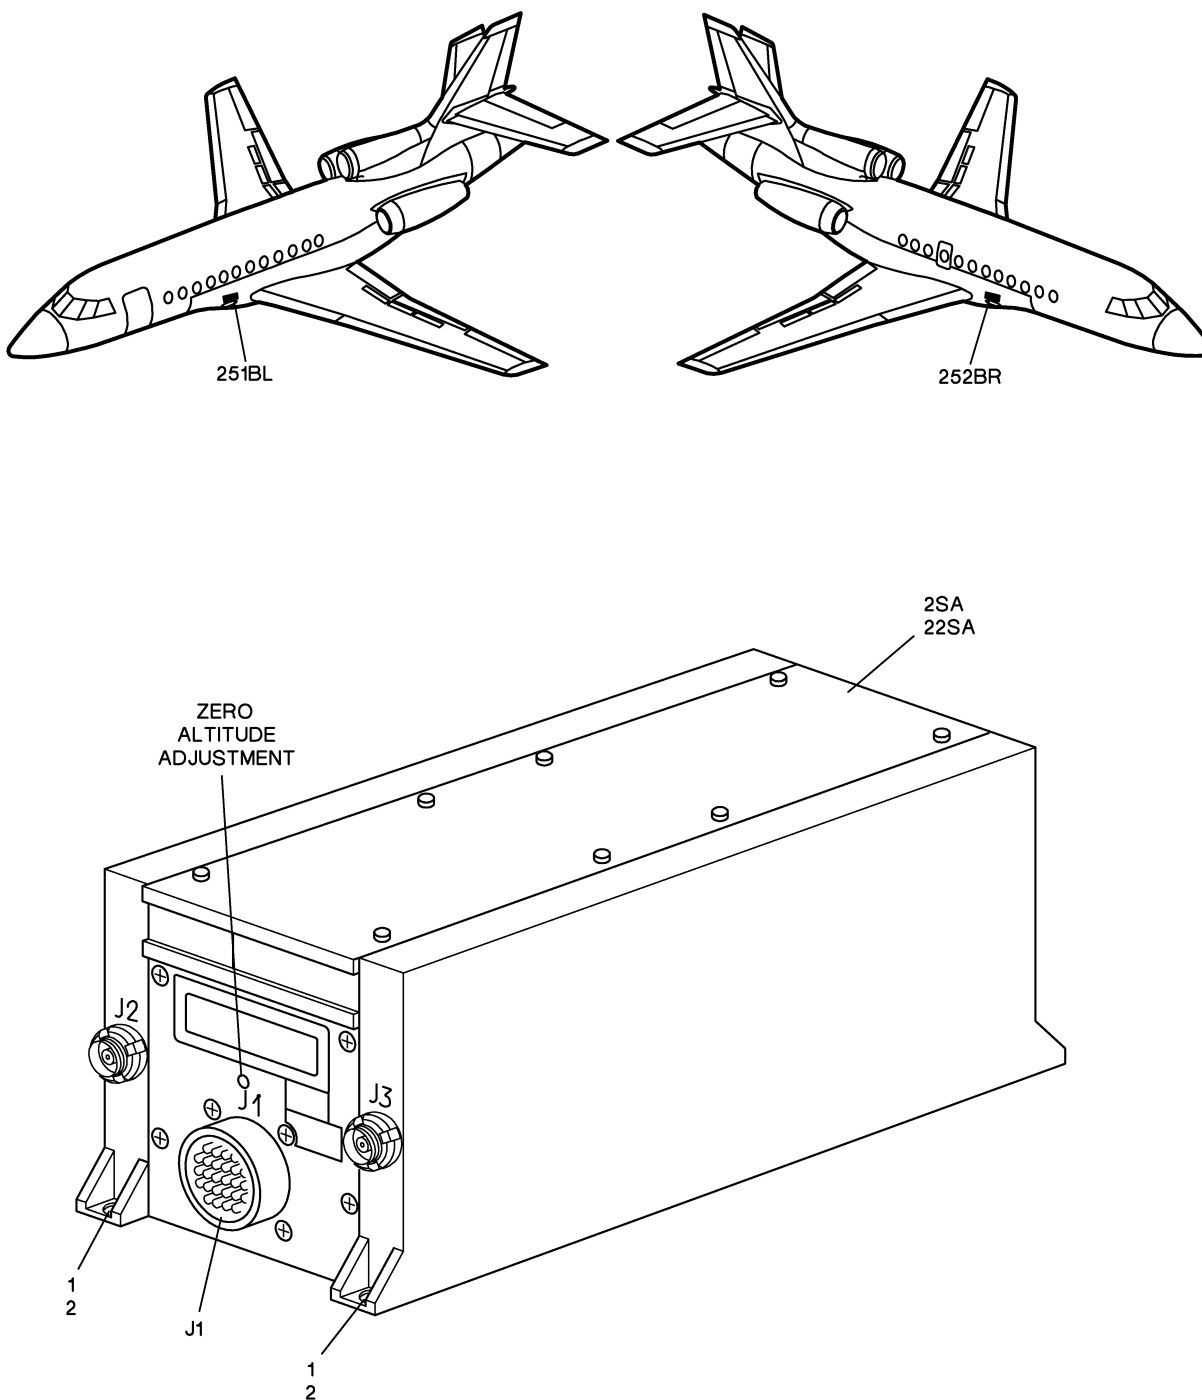
**Figure 1: Removal/Installation of Radio Altimeter**

- A. Remove fuselage fairing fillet (Refer to **TASK 53-60-01-900-801**) (**fig. 1**):

Refer to **fig. 1**

- A. De-energize the aircraft systems (Refer to [TASK 24-00-00-860-801](#), paragraph "De-energization with Electrical Ground Power Unit").
- B. Install fuselage fairing fillet (Refer to [TASK 53-60-01-900-801](#)) (**fig. 1**):
  - (1) For radio altimeter 1 ([2SA](#)):
    - ([251BL](#)).
  - (2) For radio altimeter 2 ([22SA](#)) (A/C with M 1875):
    - ([252BR](#)).
- C. Disconnect the electrical ground power unit (Refer to [TASK 24-00-00-860-801](#), paragraph "Disconnection of the Electrical Ground Power Unit").

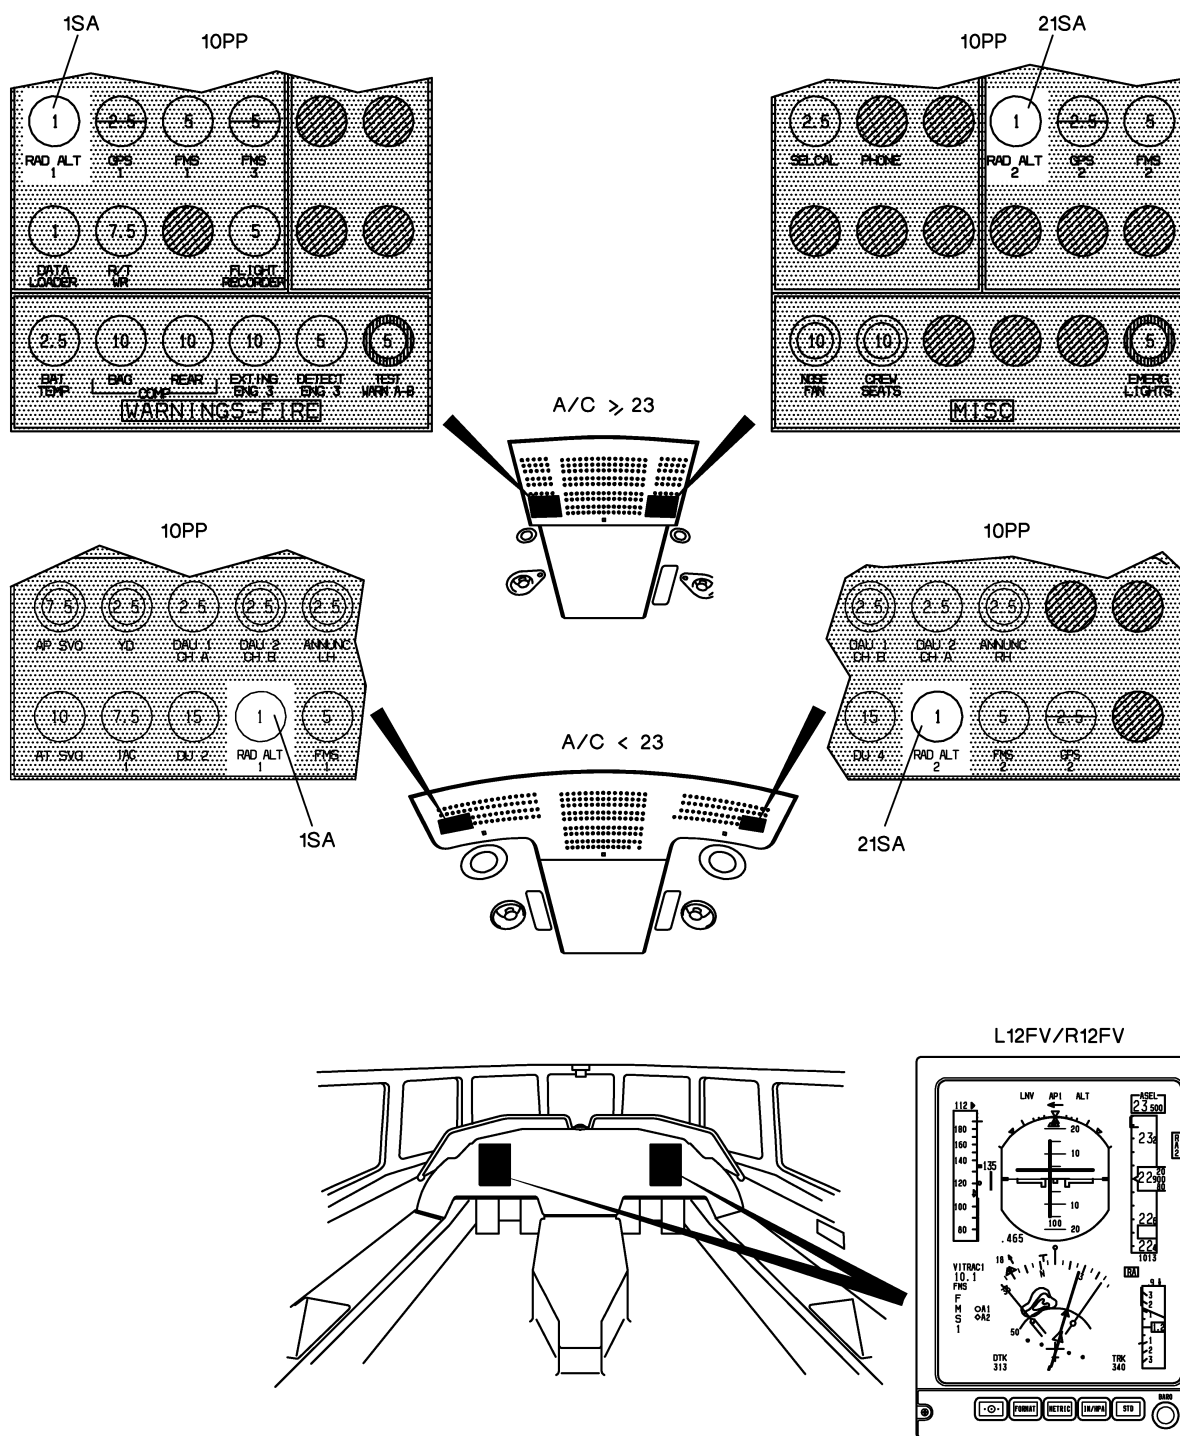
### Figure 2: Location of Cockpit Controls

- (7) In the cockpit, on circuit breaker panel (**10PP**), disengage the relevant circuit breaker(s) (**fig. 2**):
  - "RAD ALT 1" (**1SA**),
  - "RAD ALT 2" (**21SA**) (A/C with M 1875).
- (8) Disconnect the zero height adjustment cable from connector J1 of the radio altimeter (**2SA**) or (**22SA**) (A/C with M 1875)).
- (9) In the cockpit, on circuit breaker panel (**10PP**), engage the relevant circuit breaker(s) (**fig. 2**):
  - "RAD ALT 1" (**1SA**),
  - "RAD ALT 2" (**21SA**) (A/C with M 1875).

- (1) Energize the aircraft systems (Refer to **TASK 24-00-00-860-801**, paragraph "Energization with the Electrical Ground Power Unit").
- (2) Operate radio altimeter (**2SA**) or (**22SA**) (A/C with M 1875)) for a minimum of 15 minutes (warm-up period).
- (3) Adjust zero altitude adjustment until a positive radio altitude shows on one of Primary Flight Display (PFD) (**L12FV**) or (**R12FV**) (**fig. 2**).

- (4) Adjust zero altitude adjustment for a zero foot display indication on one of PFD (**L12FV**) or (**R12FV**) (**fig. 2**).

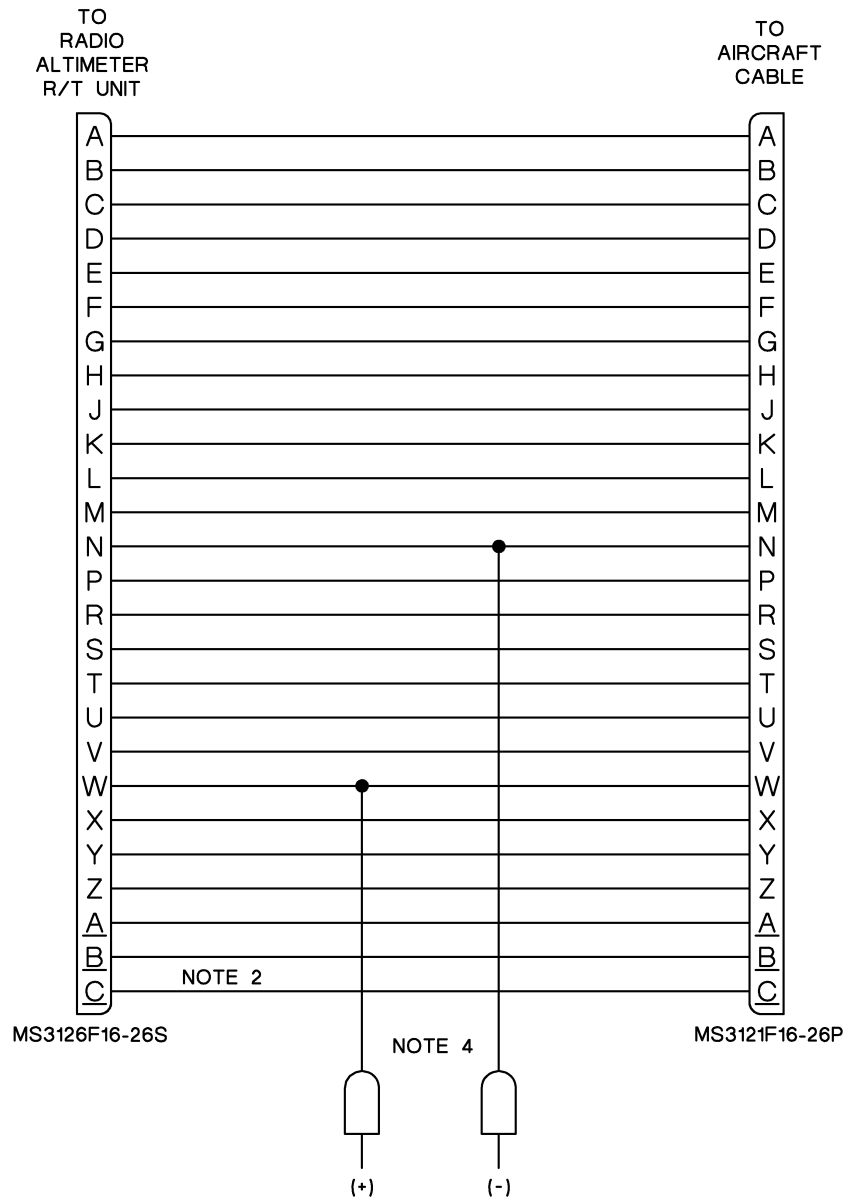
1. ALL WIRING 22 AWG, EXCEPT AS NOTED.
2. WIRING FOR PINS B AND C IS 20 AWG.
3. LENGTH OF CABLE IS SIX INCHES.
4. LENGTH OF DVM LEADS ARE AS REQUIRED.  
CONNECT PLUG TO LEADS AS REQUIRED TO CONNECT TO DVM.

**NOTE:** There are two ways to do the zero ground adjustment procedure. Method A is the recommended method because it supplies a more accurate adjustment of the zero height. Method B is the alternative method. If the cable shown in figure 3 is not available or cannot be fabricated, then use method B to adjust the zero height.
