A/C Regn: **D-AHRN**

Job Description: **SB F900EX-0426**

F900EX-426

**EQUIPMENT AND FURNISHINGS  
PASSENGER COMPARTMENT  
REMOVAL OF DIVAN AIR CURTAIN**

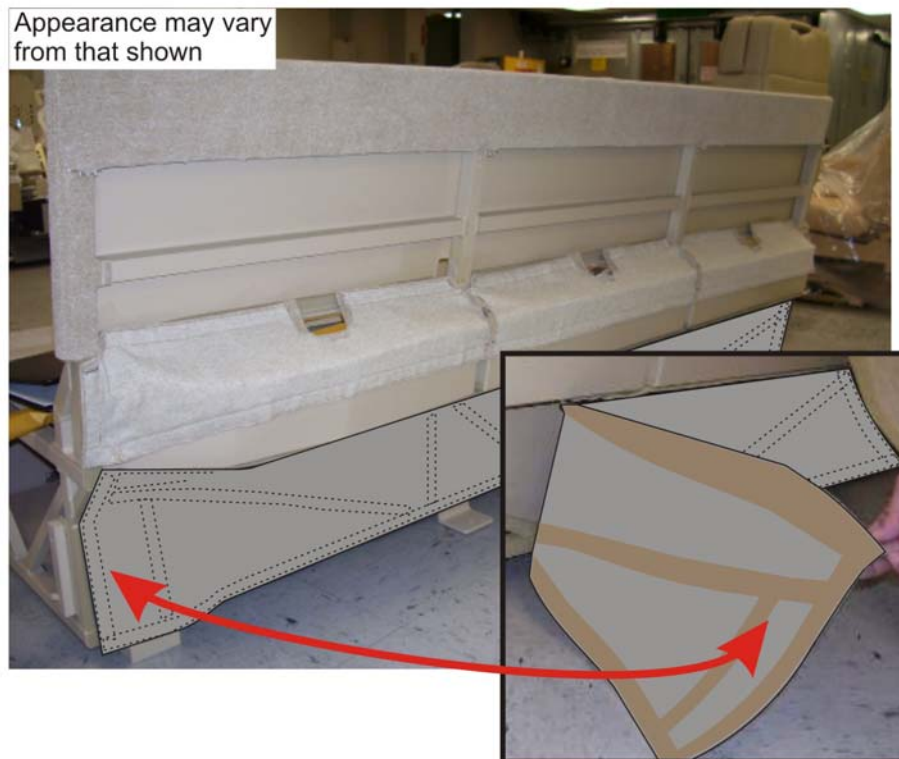
**Figure 1: EXISTING DIVAN AIR CURTAIN**

On aircraft in service, the side facing divan outboard curtain / blanket may have been installed without approved data. In addition, some of the materials do not consistently pass regulatory burn requirements. The air curtain / blanket is attached to the outboard side of the divan using hook and loop fasteners.

- (1) The aircraft must be in the maintenance configuration (Refer to [TASK 20-00-00-910-801](#)).
- (2) Remove one of the divan drawers to facilitate inspection for divan air curtain(s) (Refer to Supplemental Maintenance Manual ATA 25).
- (3) Inspect divan(s) for an outboard divan air curtain (Refer to [fig. 1](#)) . If present, continue with service bulletin. If divan(s) air curtain is not installed, no further action required.

Refer to [fig. 1](#).

- (1) Remove divan air curtain(s) from aircraft and dispose (Refer to [fig. 1](#)).

NOTE: Depending on the aircraft configuration, the removal of the divan may be necessary.
